APPLEWOOD SANITATION DISTRICT

2023 SYSTEM STATUS REPORT

NOVEMBER 2023

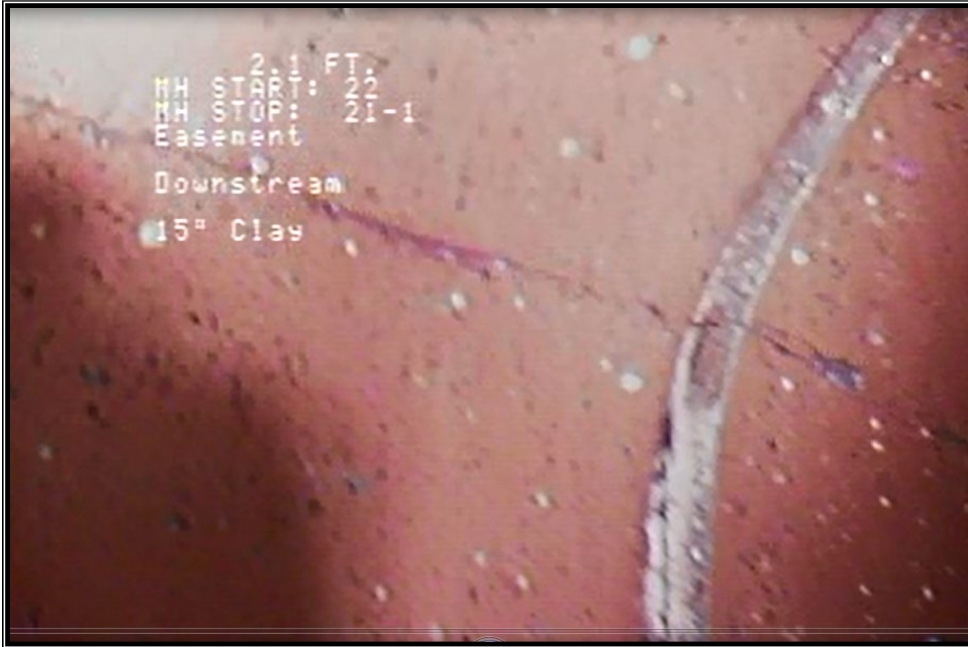
LIGHT

1. CRACKS

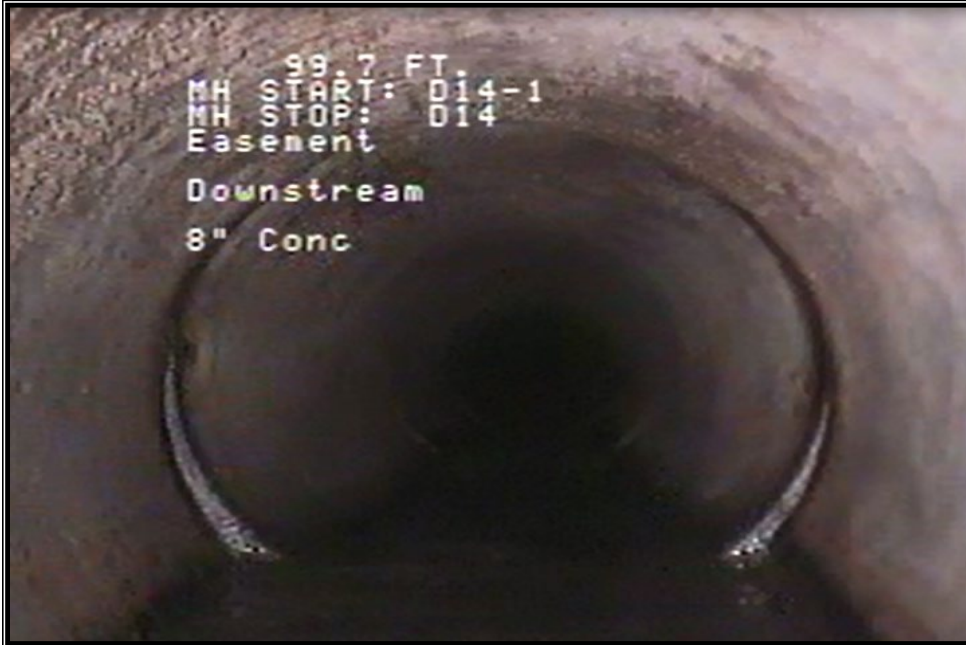
LIGHT

2. JOINTS

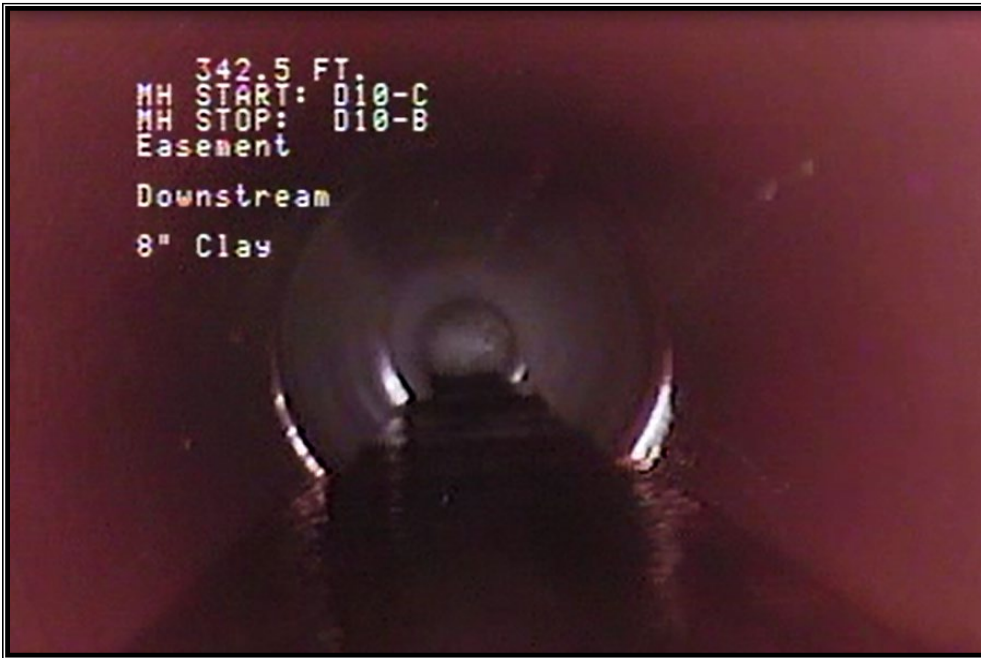
LIGHT

3. SAG

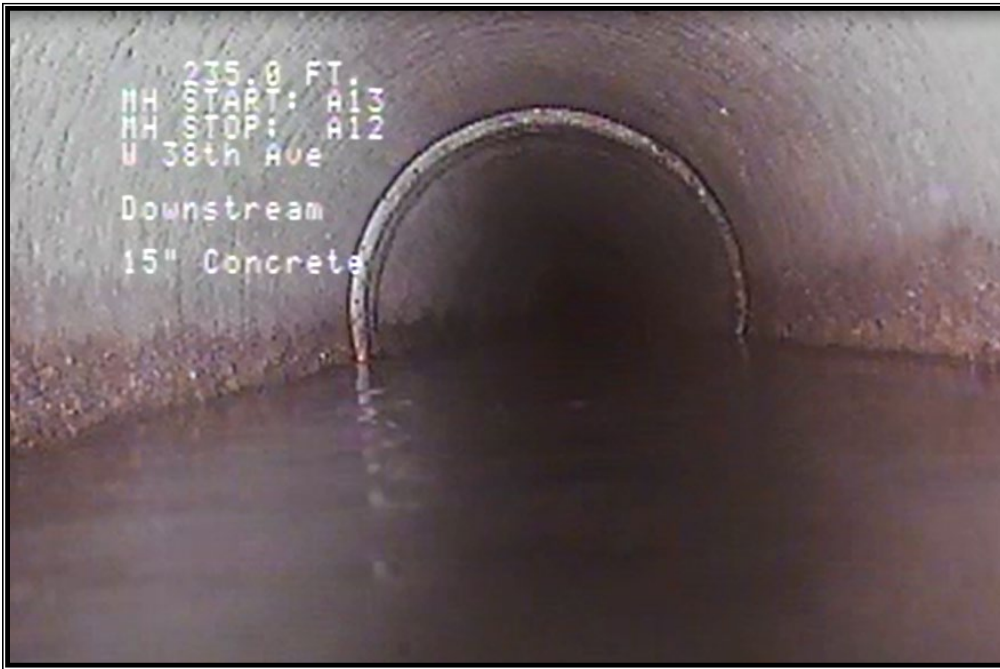
LIGHT

4. DETERIORATION

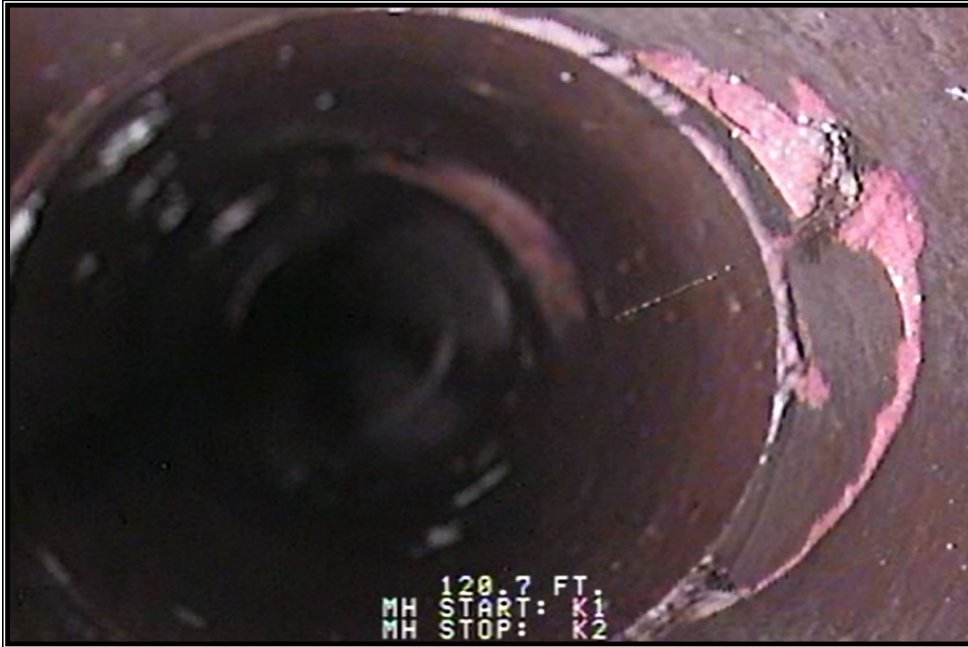
MODERATE

5. BROKEN

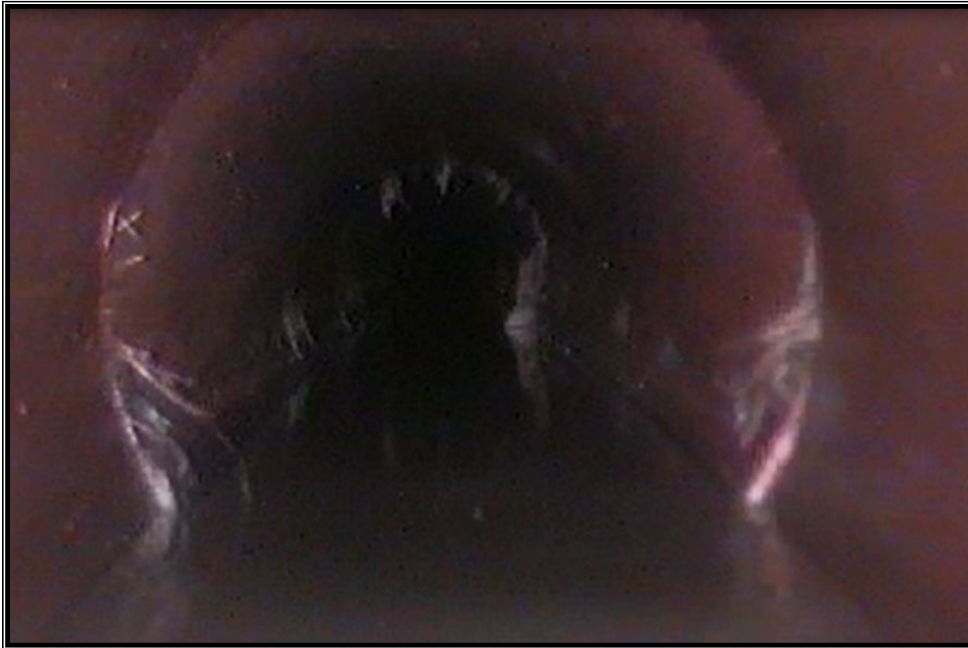
LIGHT

6. ROOTS

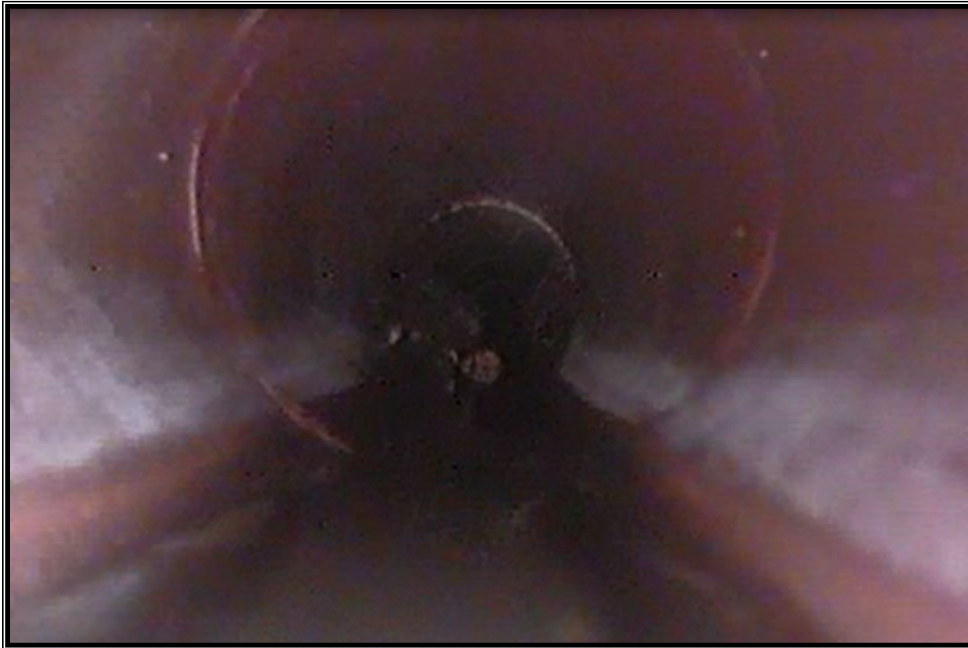
LIGHT

7. DEBRIS

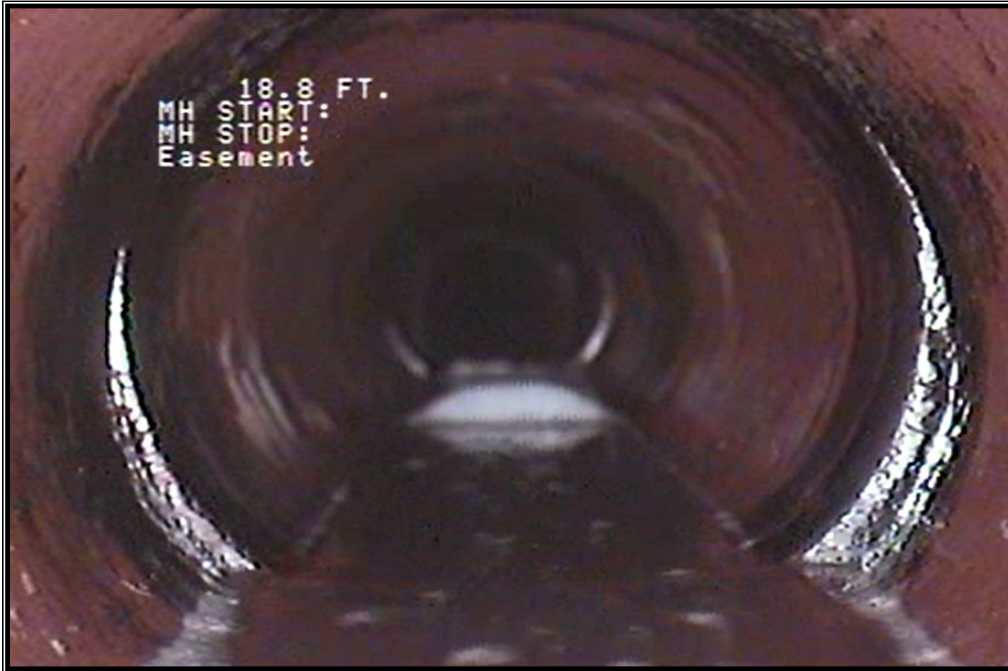
LIGHT

8. INFILTRATION

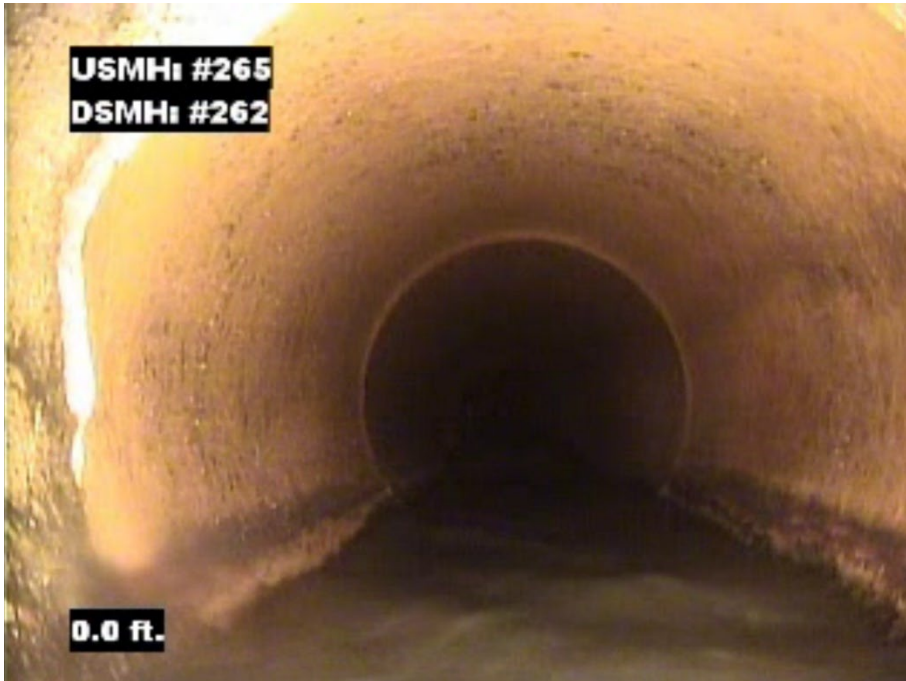
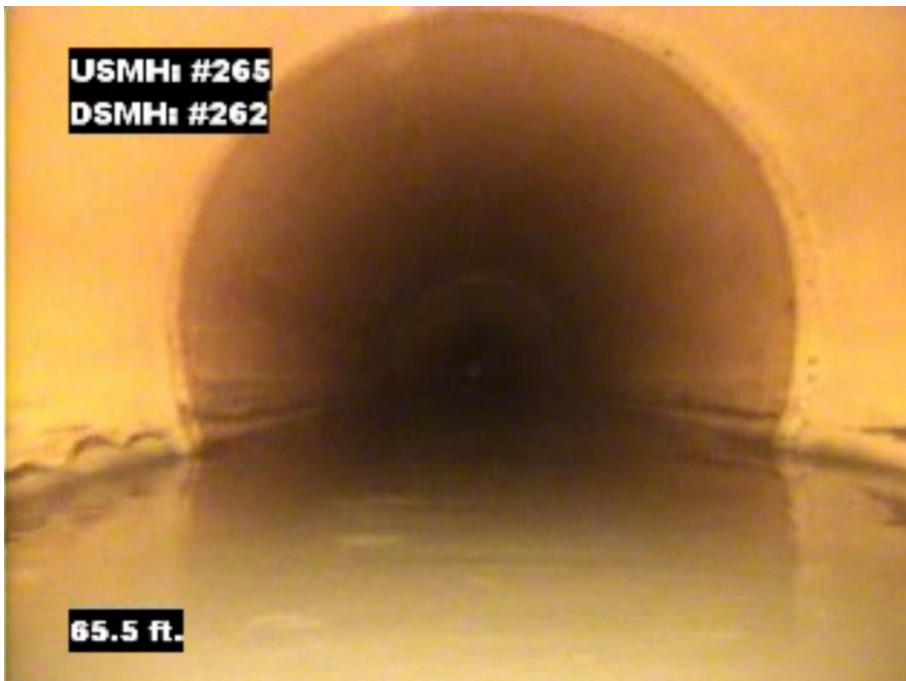
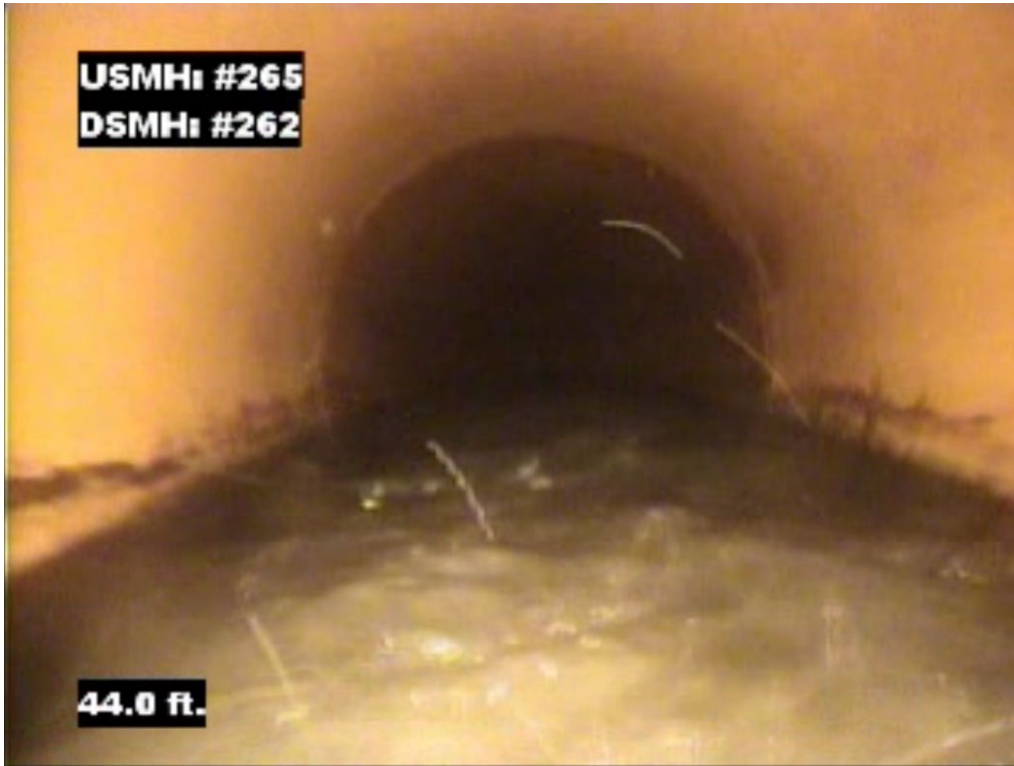
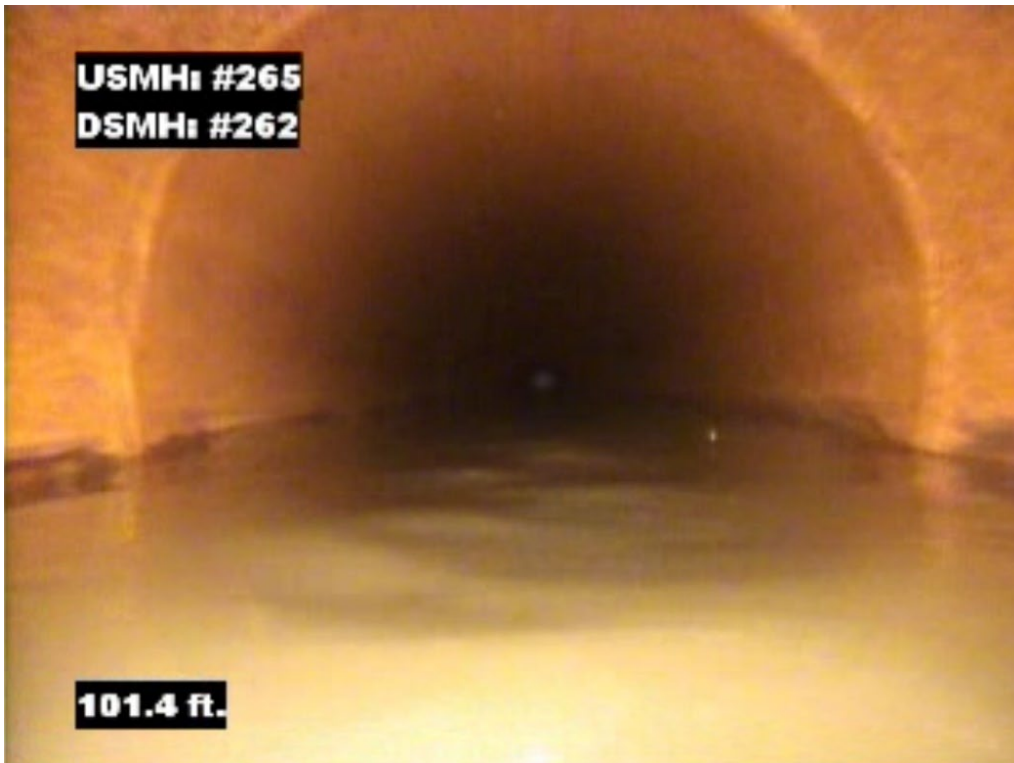
1. W. 32nd Avenue (Zone D) – Manhole 265 to Manhole 262. – Extensive sag throughout. Excavate and replace approximately 169 LF of 8" mainline. Full line replacement MH to MH.

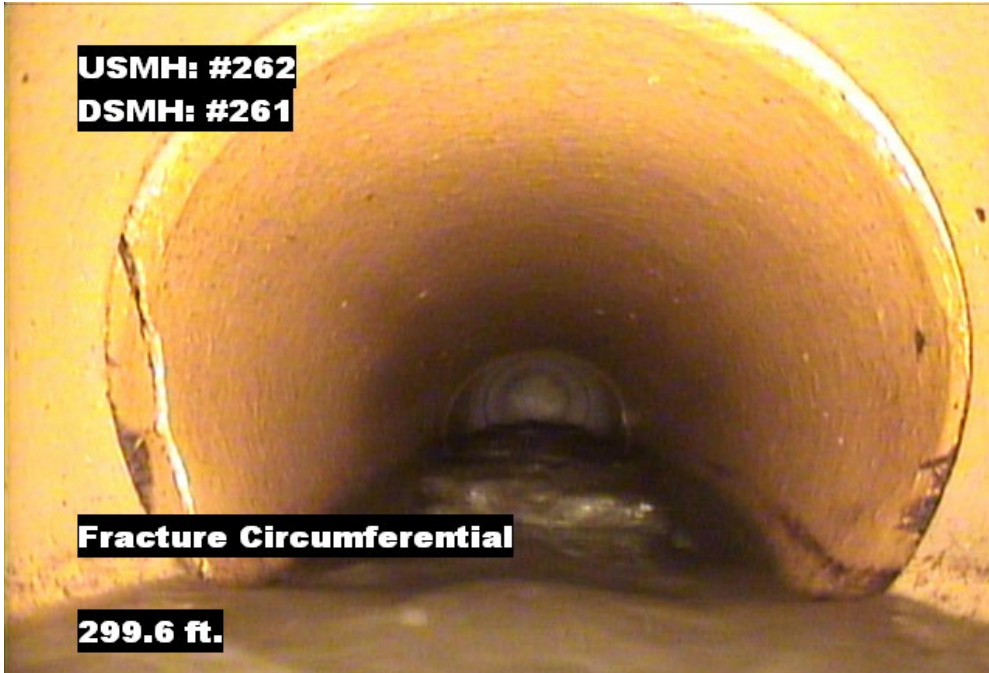
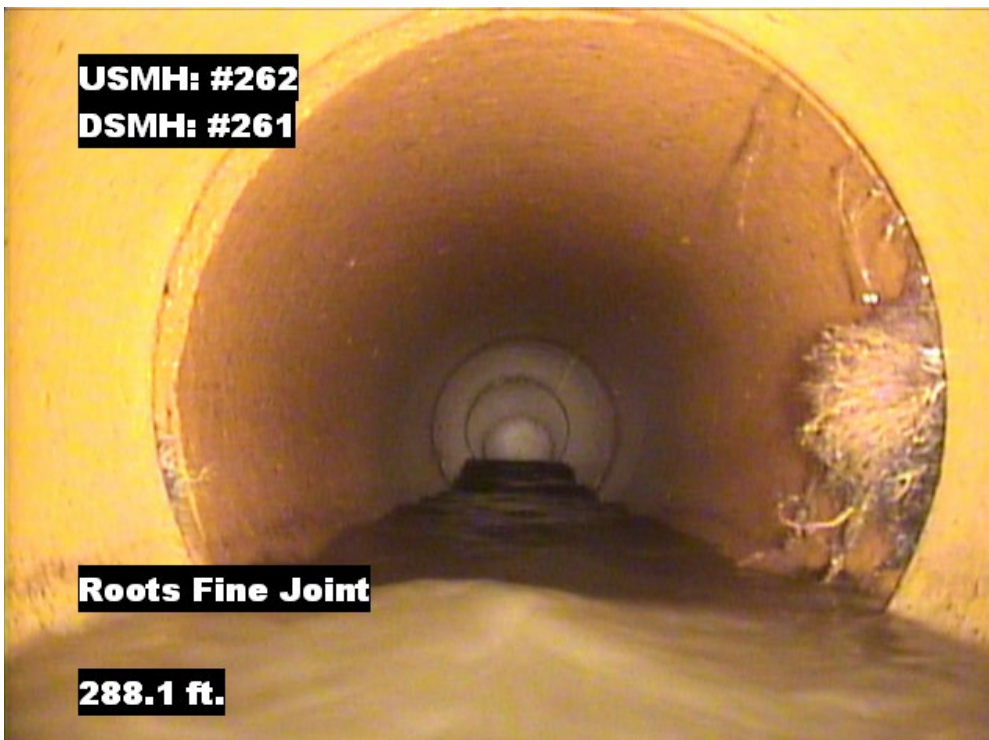
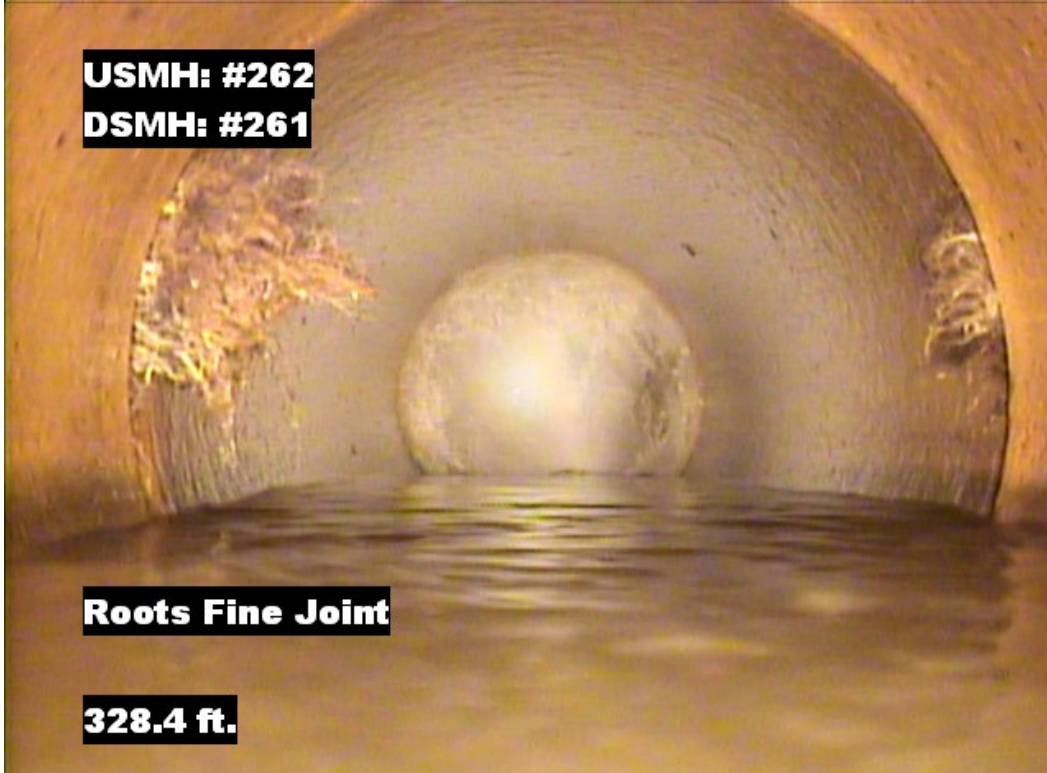
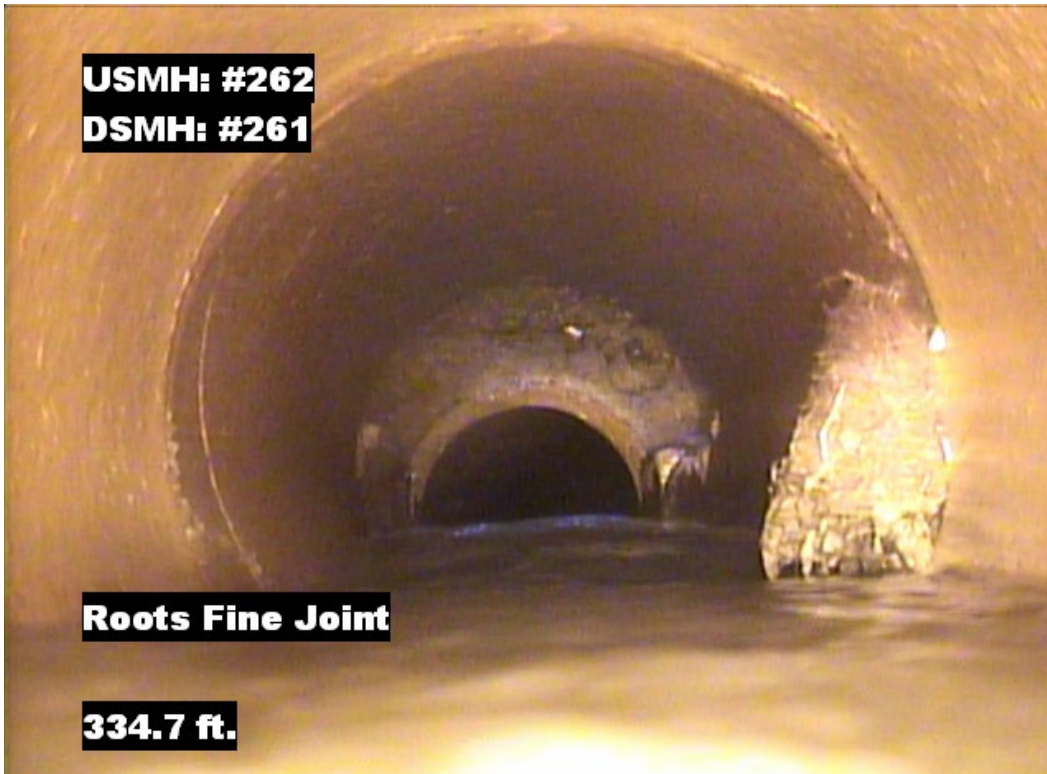
2. Alkire Court (Zone D) – Manhole 262 to Manhole 261 – Broken pipe, root intrusion throughout, moderate sag throughout. Excavate and replace approximately 337 LF of mainline.

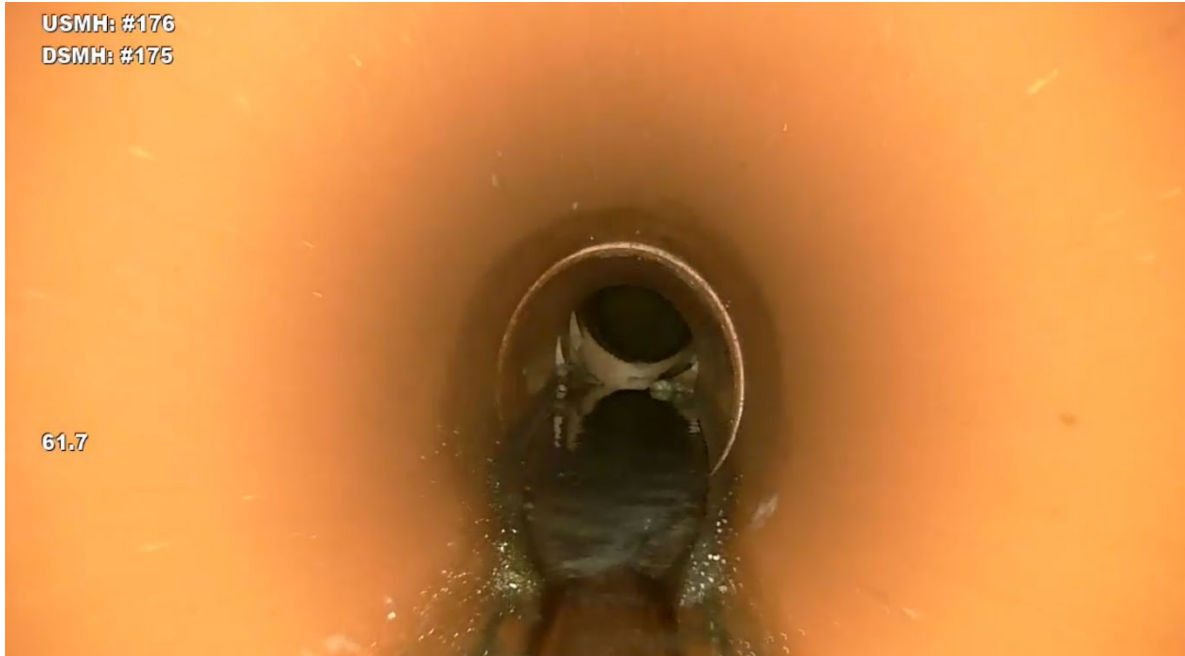
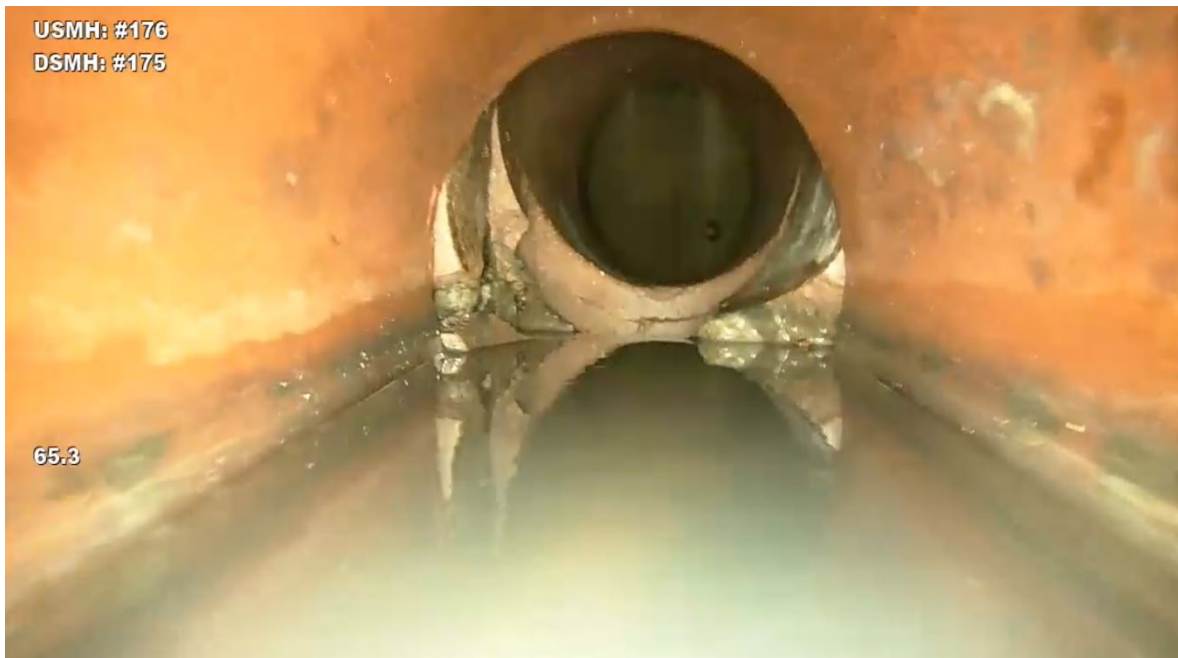
- 3. Elderberry Rd (Zone A) – Manhole 176 to Manhole 175 – Extensive broken pipe at drop MH 175. Point Repair.

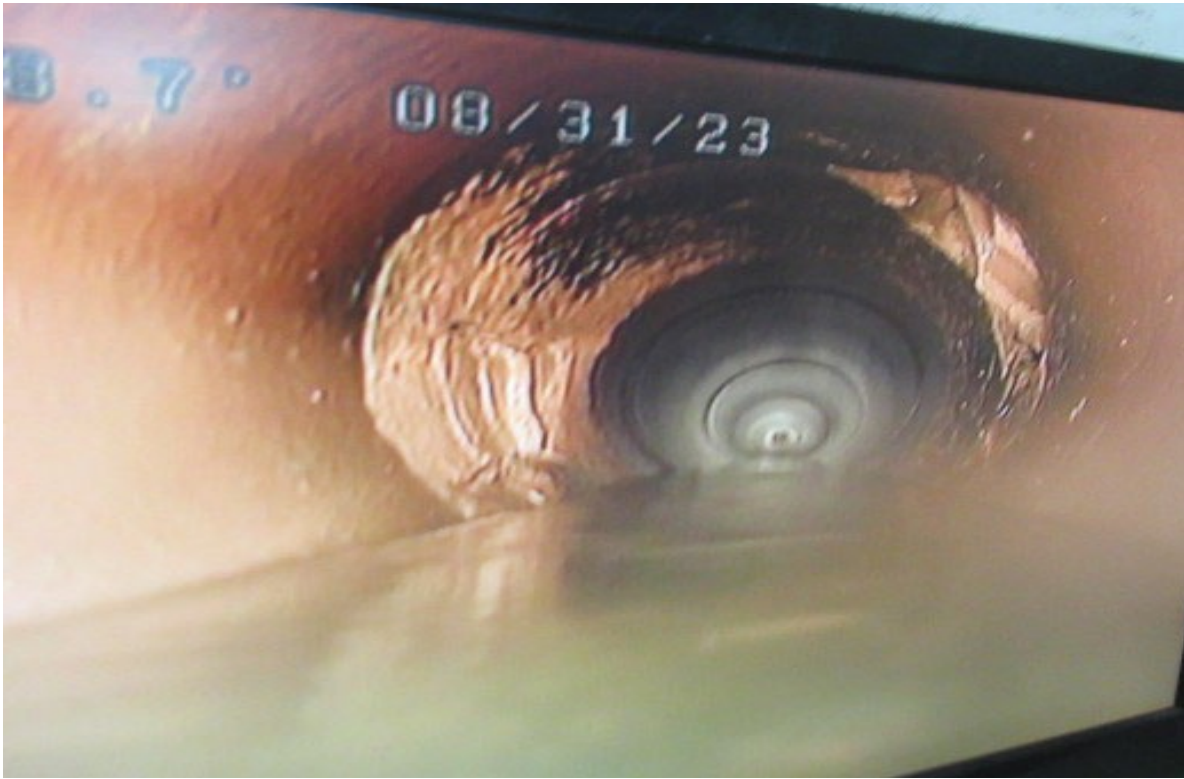
- 4. Crabapple Rd (Zone F) – Manhole 92 to Manhole 78- Broken pipe at service. Point Repair - 70 LF from MH 92. Replace 8' of pipe.

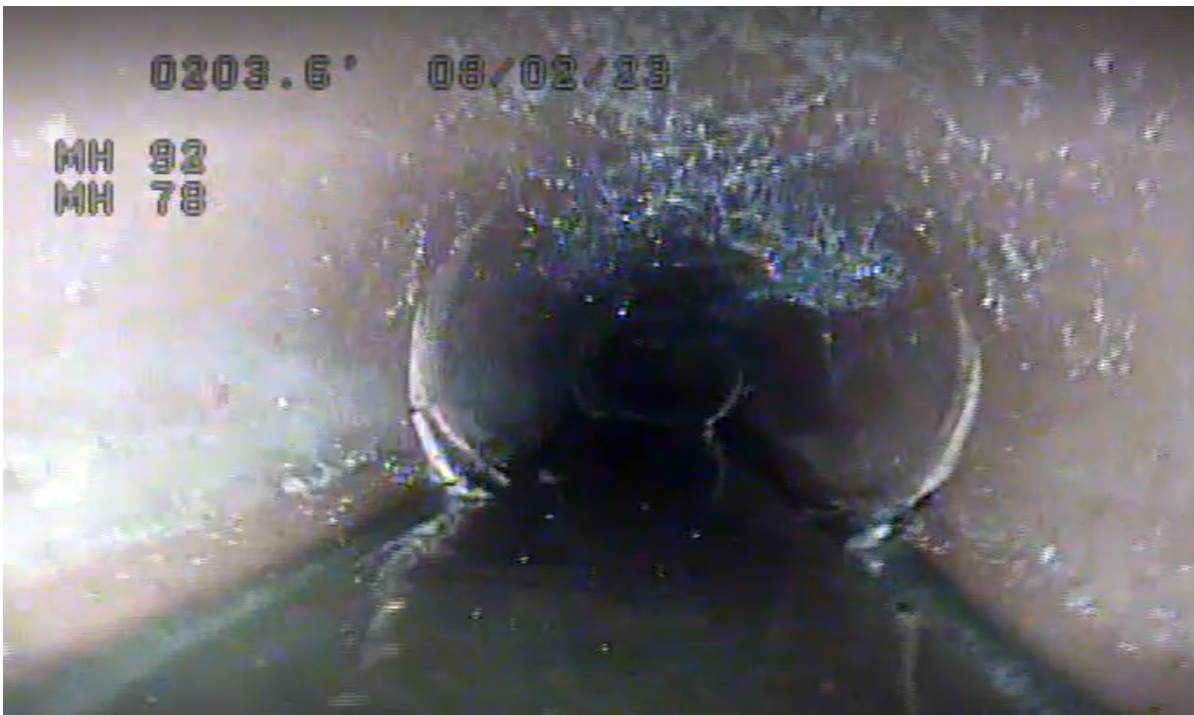
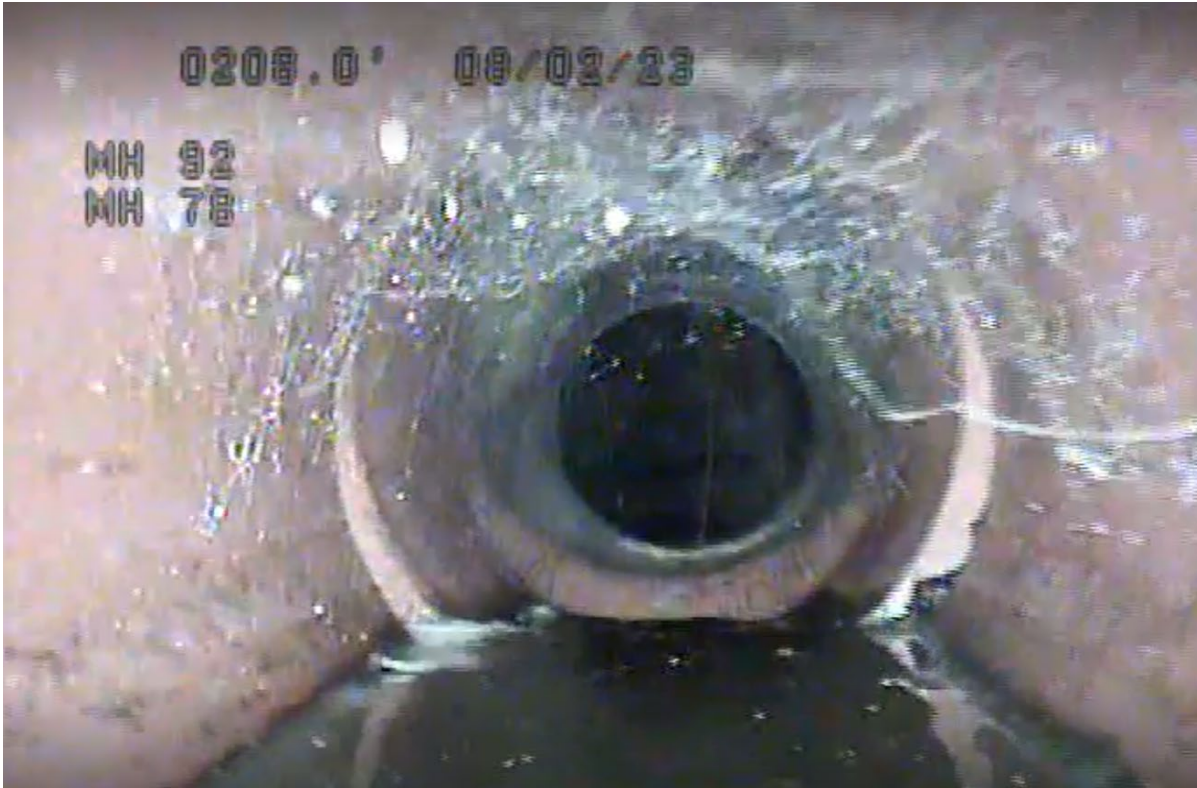
- 5. Crabapple Rd (Zone F) – Manhole 92 to Manhole 78- Broken pipe and offset joint at Drop MH 78. Point Repair. Replace 8' of pipe.

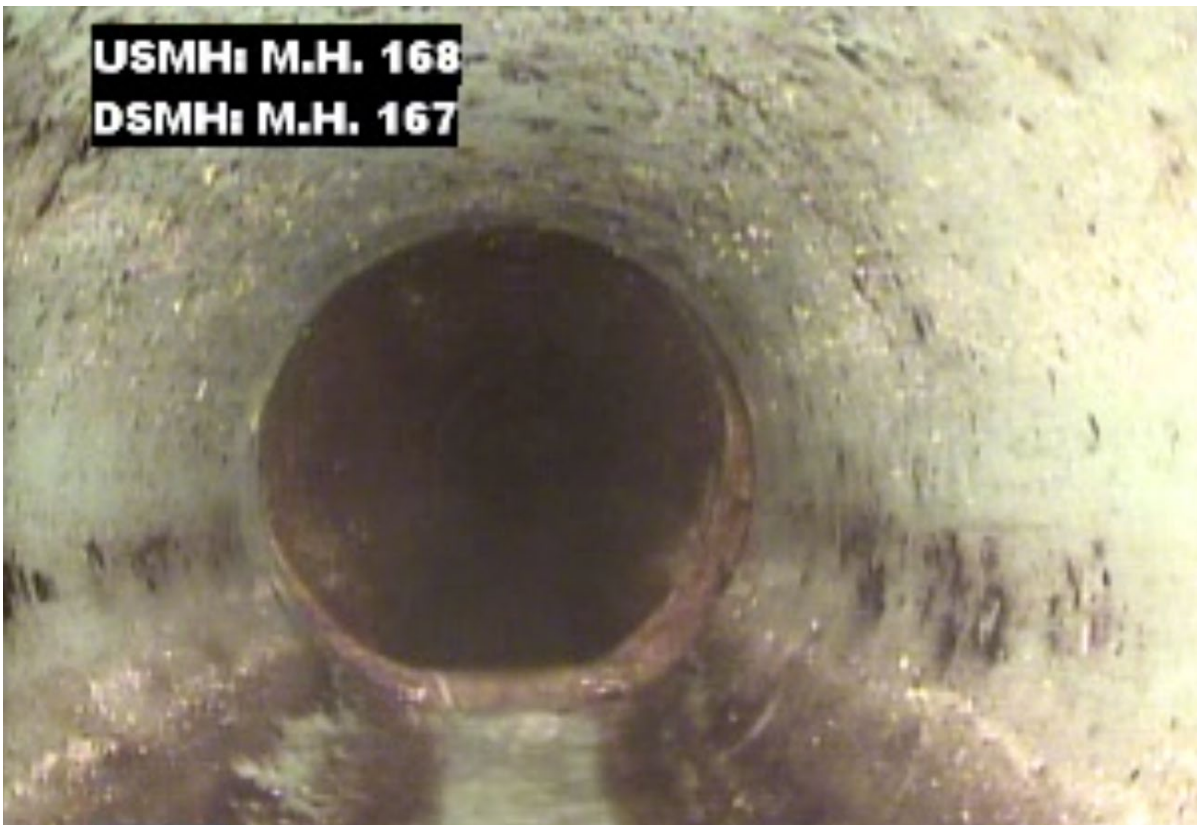
- 6. Zinnia Ct (Zone D) – Manhole 168 to Manhole 167 – Offset joint by MH 167 that prevents slip lining. Point Repair at MH 167

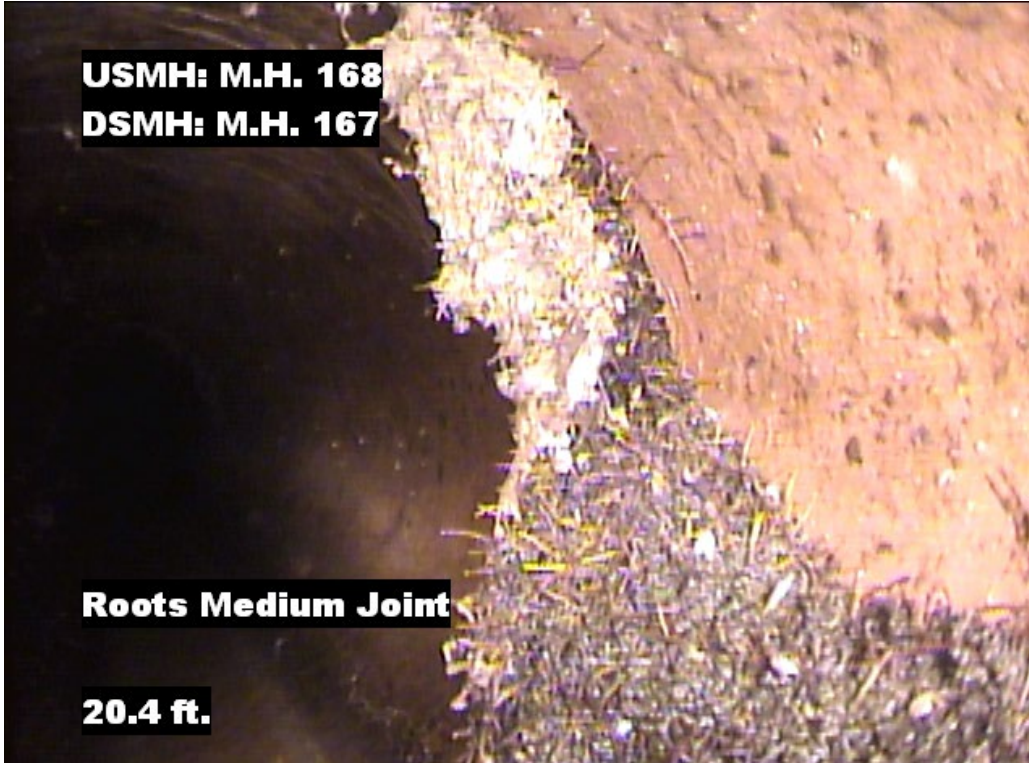
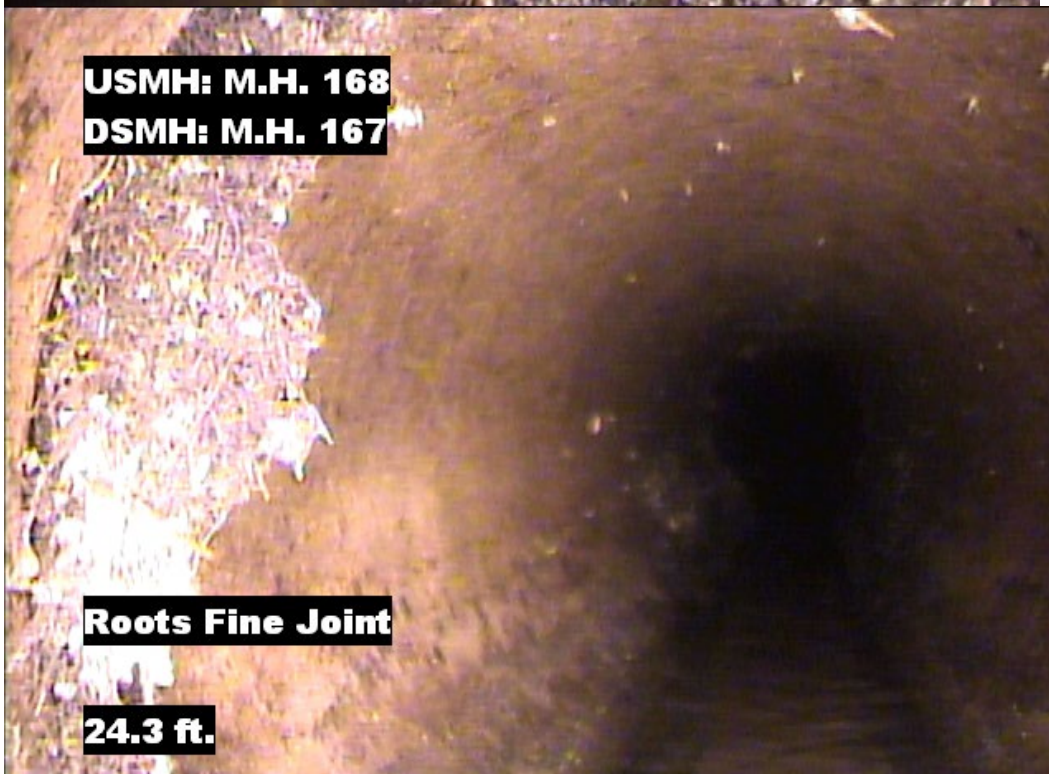
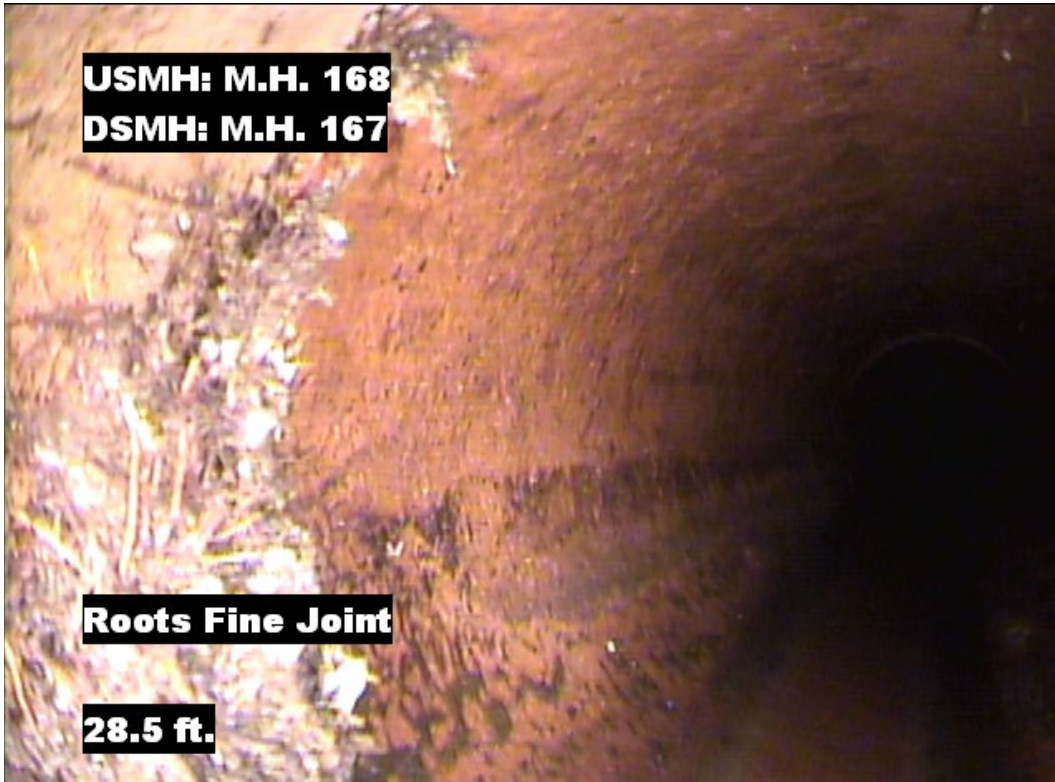
1. Zinnia Court (Zone D) – Manhole 168 to Manhole 167 – Moderate root intrusion at joints, offset joints. Slip line 378 LF after offset joint point repair at PVC at MH 167. From 2023, offset joint issue.

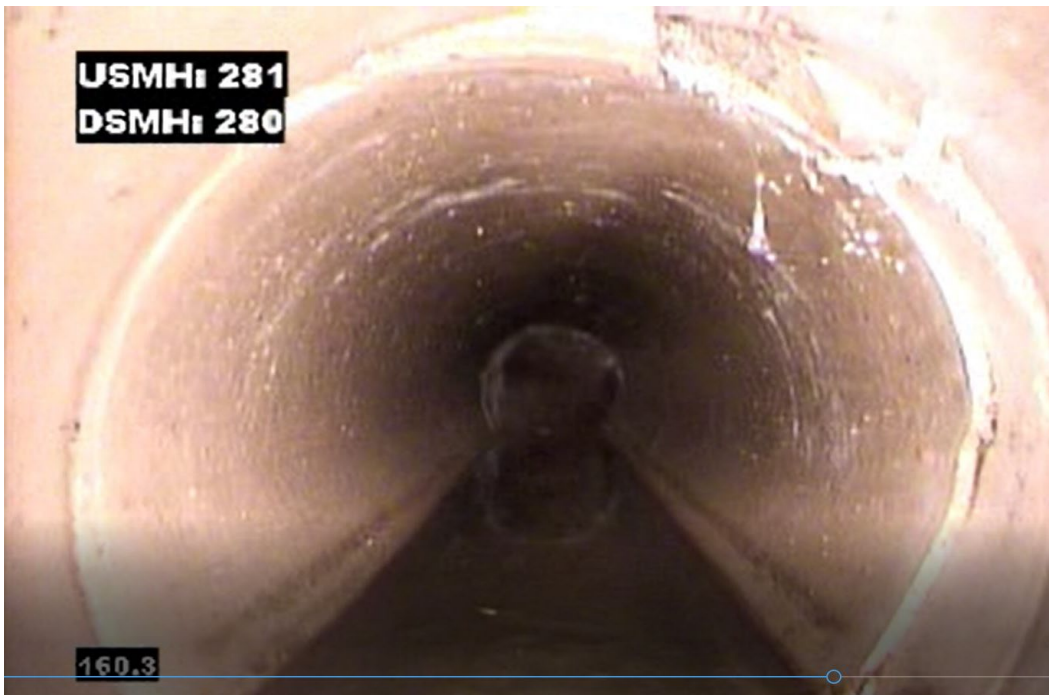
2. Kendrick Street Easement (Zone B)– Manhole 281 to Manhole 280 – Moderate cracks, broken pipe. Root intrusions throughout line. Slipline of 170 LF.

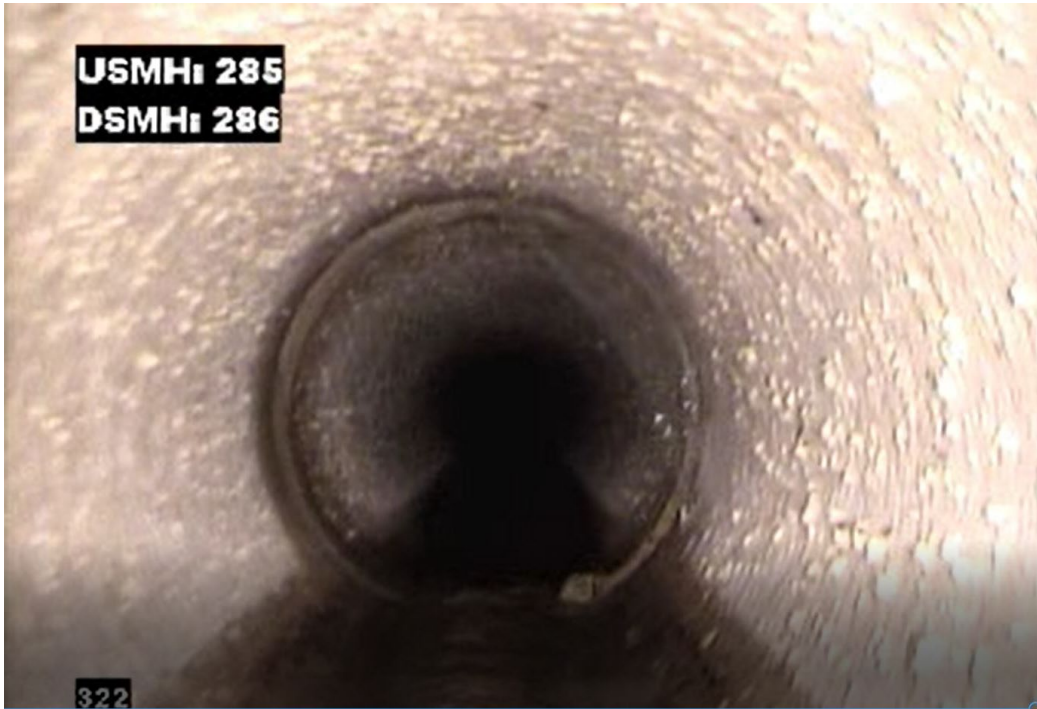
- 3. Joyce Way (Zone B) – Manhole 285 to Manhole 286 – Encrustation buildup throughout line, infiltration issues. Remove Encrustations and Slipline of 343 LF.

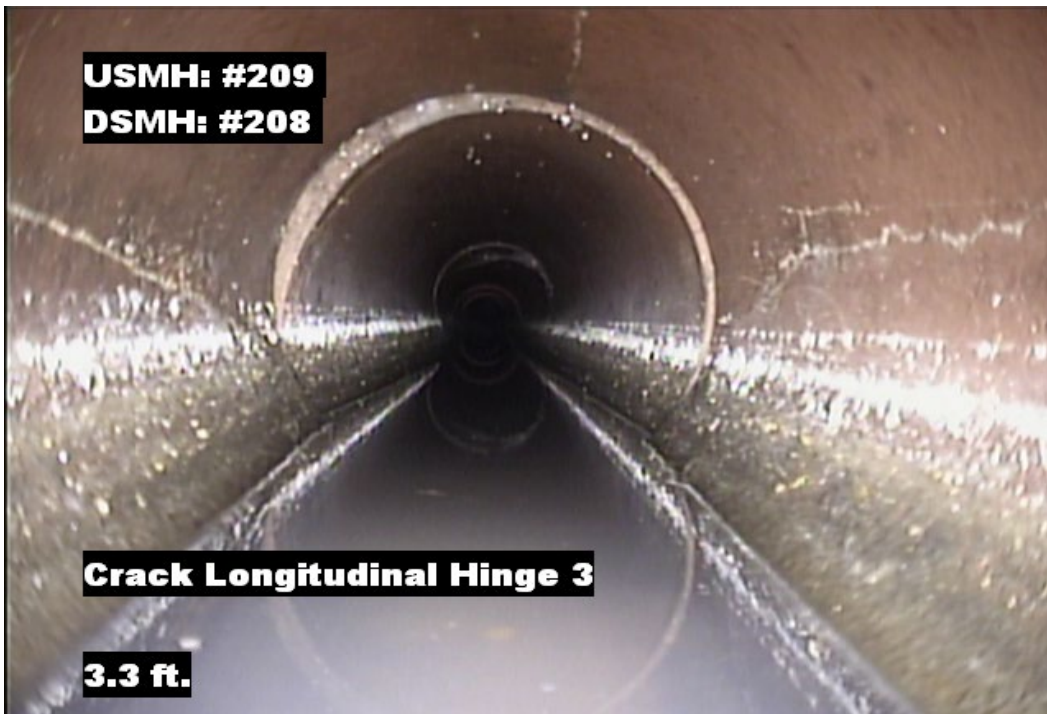
- 4. Applewood Ridge Road (Zone A) – Manhole 209 to Manhole 208 – Moderate cracks, light Off-sets. Slipline of 51 LF.

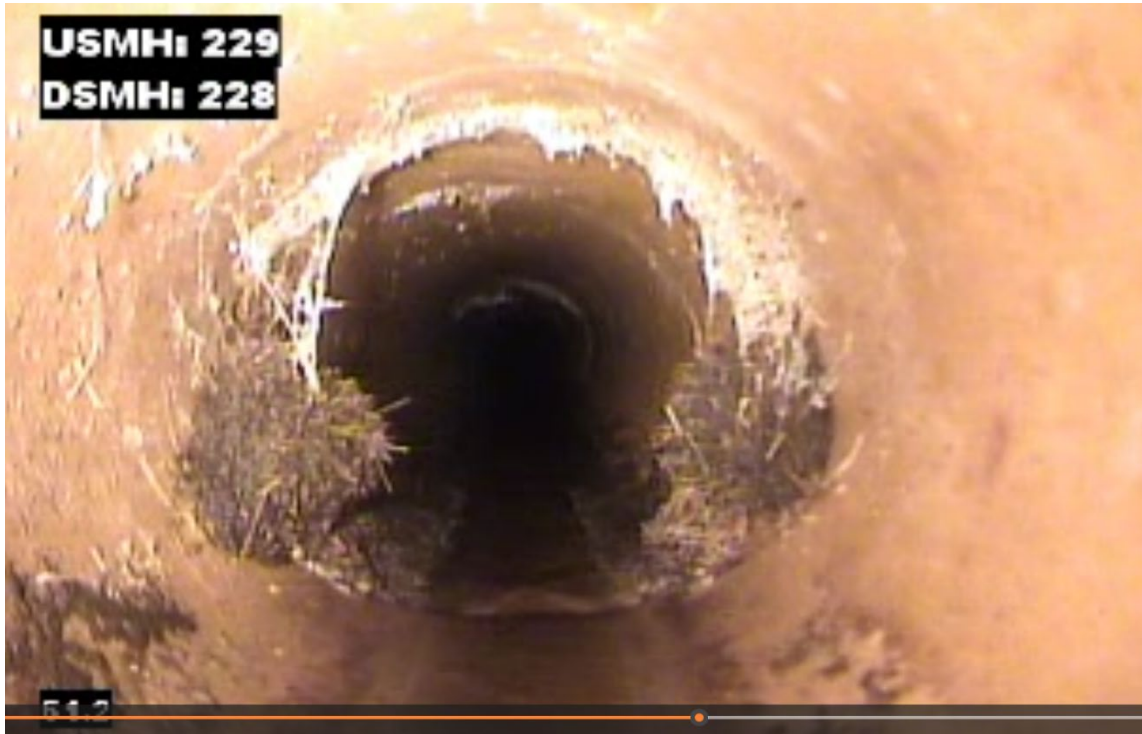
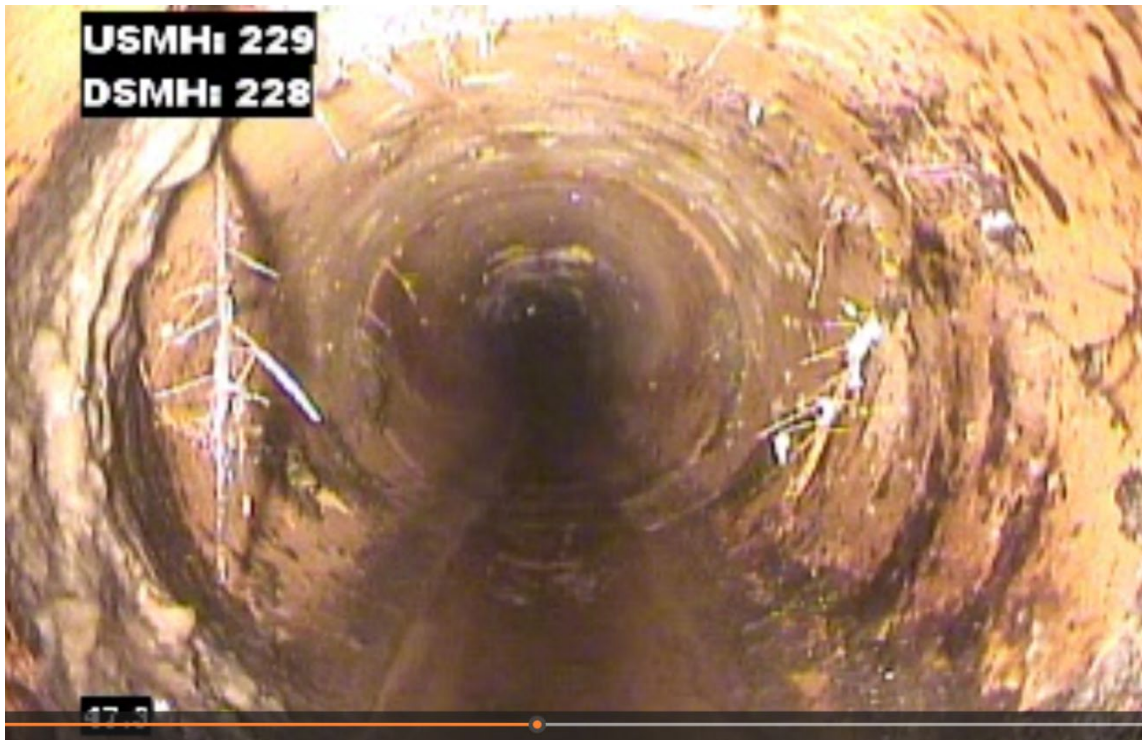
- 5. Echo Dr Easement (Zone B) – Manhole 228 to Manhole 229 – Moderate cracks, and roots, Missing MH 228. Slipline of 110 LF.
